City of Newark, New Jersey  
Feasibility Study

# POLLUTION ABATEMENT PROGRAM

Clinton Bogert Associates  
Consulting Engineers  
September, 1978  
Revised January, 1979

Re: Pollution Abatement

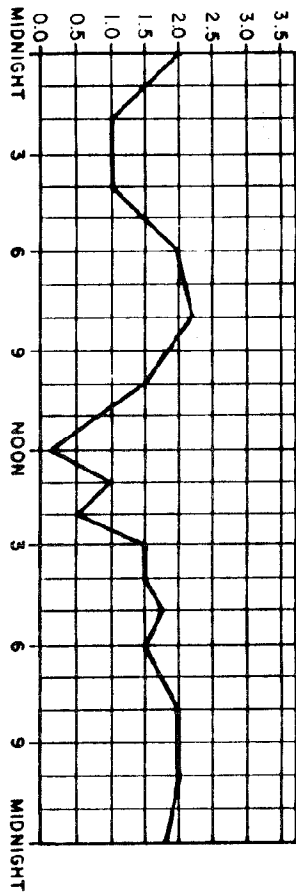
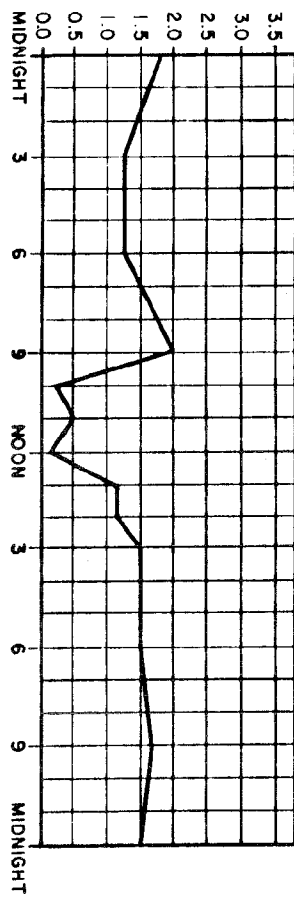
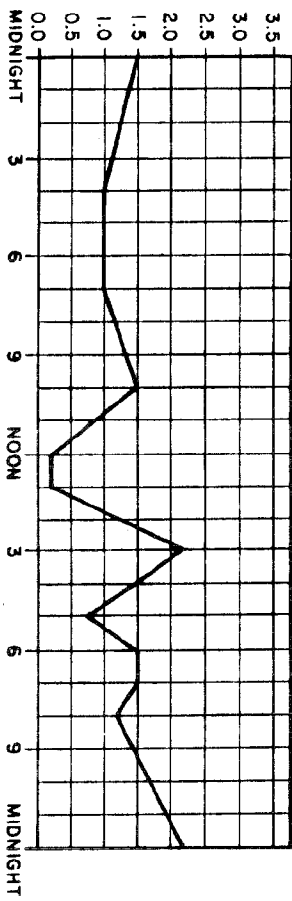
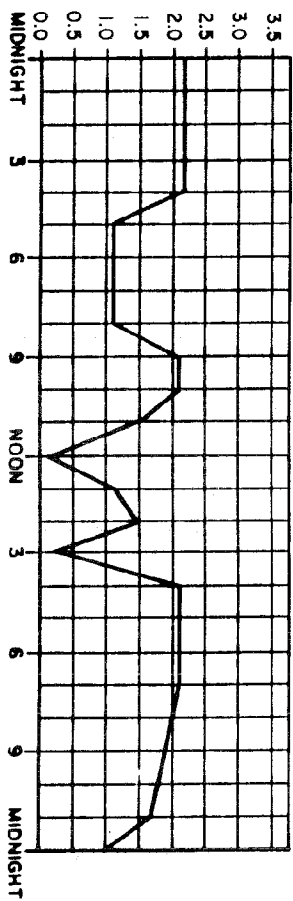
PLATE 3

The flow rates determined in the Roanoke outfall sewer during the period April 24, 1978 to May 30, 1978 are shown on Plates 3 & 4. These rates have been corrected to eliminate tidal effects. Minimum flow rates were found about noon with higher rates in the morning and afternoon. The flow meter data was supplemented by instantaneous measurements obtained before, during, and after the meters were

installed. Maximum peak dry weather flow rates of 2.2 mgd and minimum flow rates of 0.2 mgd were recorded. The apparent constant flow rate over the weekend (April 29 and April 30) cannot be explained. The flow meter was checked on Thursday April 27 and found to be operational. On Monday, May 1, the battery and chart were changed and the calibration was checked. No errors in calibration or timing were noted and that meter remained in service during the next week. Similar uniform and high discharges occurred at other unusual times for shorter periods. Most of the flow in this sewer is discharged by two companies, Arkansas Chemical and Sun Chemical. Unusual flow patterns may result from variations in processes and work shifts at these plants.

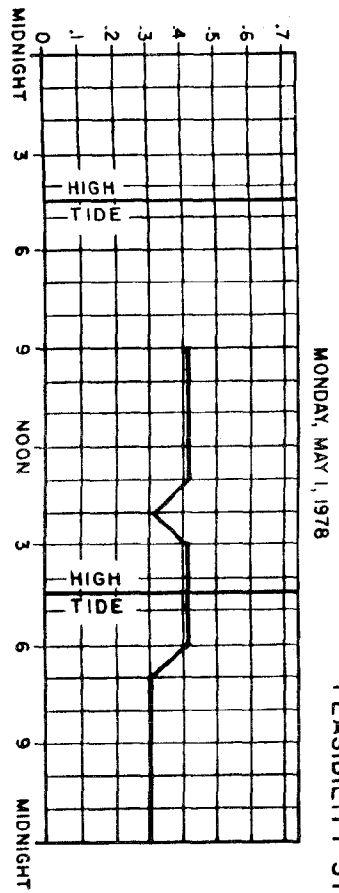
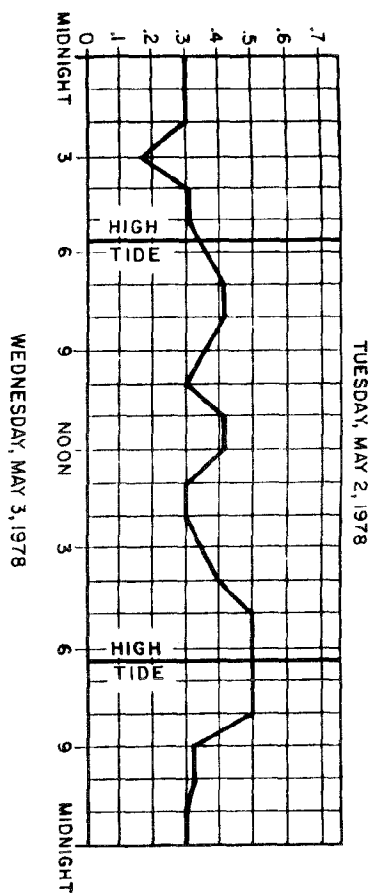
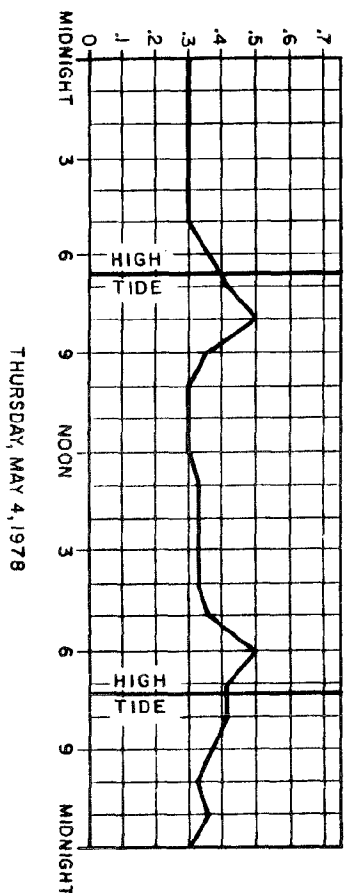
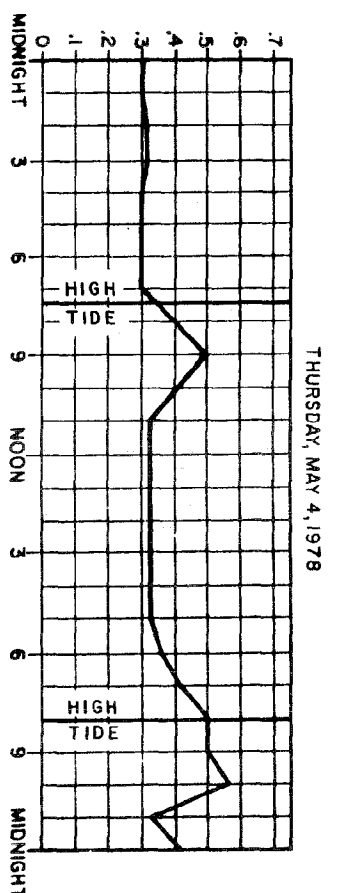
Plates 5 and 6 show diurnal flow patterns recorded in the Doremus Avenue interceptor during the period May 1 to May 5. The flow meter malfunctioned on May 6 and no readings were obtained over the weekend. Weekend data for April 22 and April 23 was included to show the effect of antecedent rainfall and springtides on the flow rate in the sewer. The flow on April 22 was about double that of the preceding dry days. The consistency with which higher flow rates coincide with higher tide periods indicates probable inflow caused by tide related fluctuations. About two inches of rain fell on April 19, saturating the ground and raising the river level. At 8:15 PM on April 22, the tide crested one foot above normal and flow in the sewer increased from below 0.8 mgd to 1.1 mgd. Weekday flow rates generally fluctuate between 0.3 and 0.4 mgd with peaks of 0.5 mgd occurring at the times of high tide. The lowest flow rate measured was approximately 0.2 mgd.

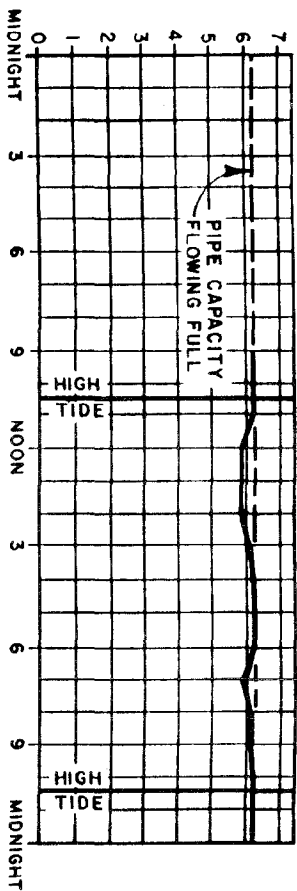
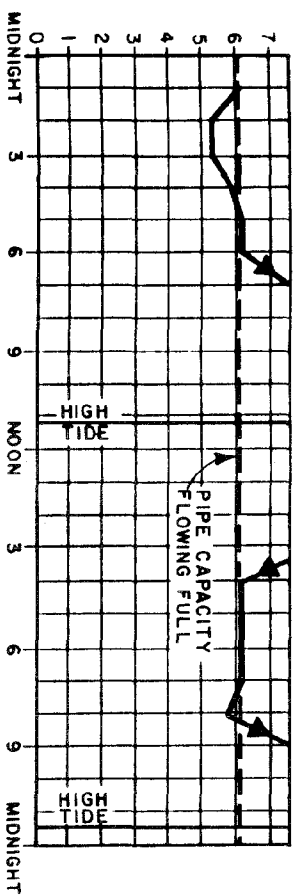
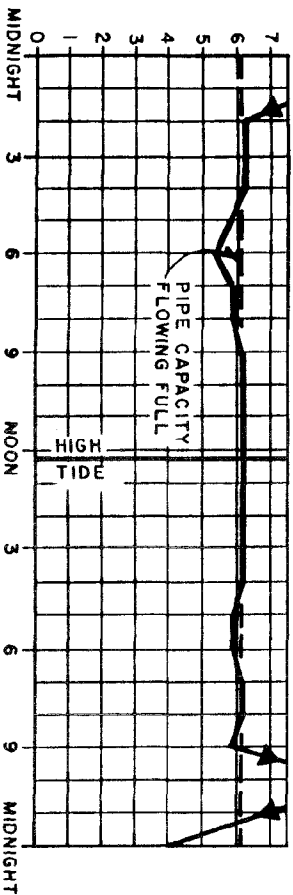
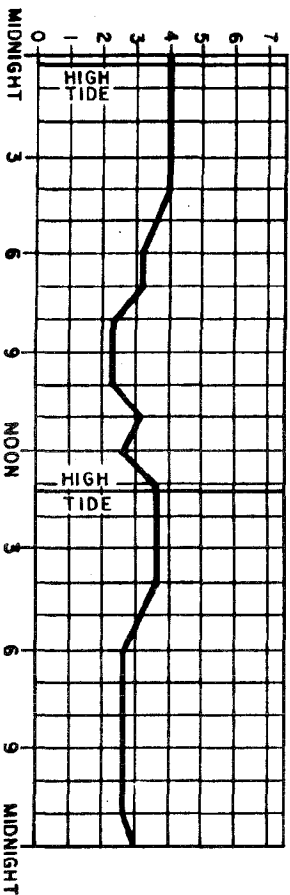
As indicated by the measured flows between 10 and 11 p.m. of May 25, higher peak dry weather flows in the Wilson Avenue interceptor than those of May 23 may be probable. With a field verified sewer gradient between manholes W-9 and W-8 of 0.0025 ft/ft the flow-full capacity of the Wilson interceptor closely approximates 6.2 mgd. The peak capacity of 4.5 mgd, cited in the PVSC Infiltration/Inflow Analysis, was computed for a monitoring point approximately 1500 feet downstream of manhole W-8. This sewer is now being resurveyed by E.T. Killam Associates to verify both the estimated capacity and amount of I/I.

NOTES:  
1- RAINFALL OF 2.75"  
ON 5/24 AND 5/25  
2- FLOW RATES ABOVE  
6.2 MGD INDICATE  
SURCHARGED PIPE

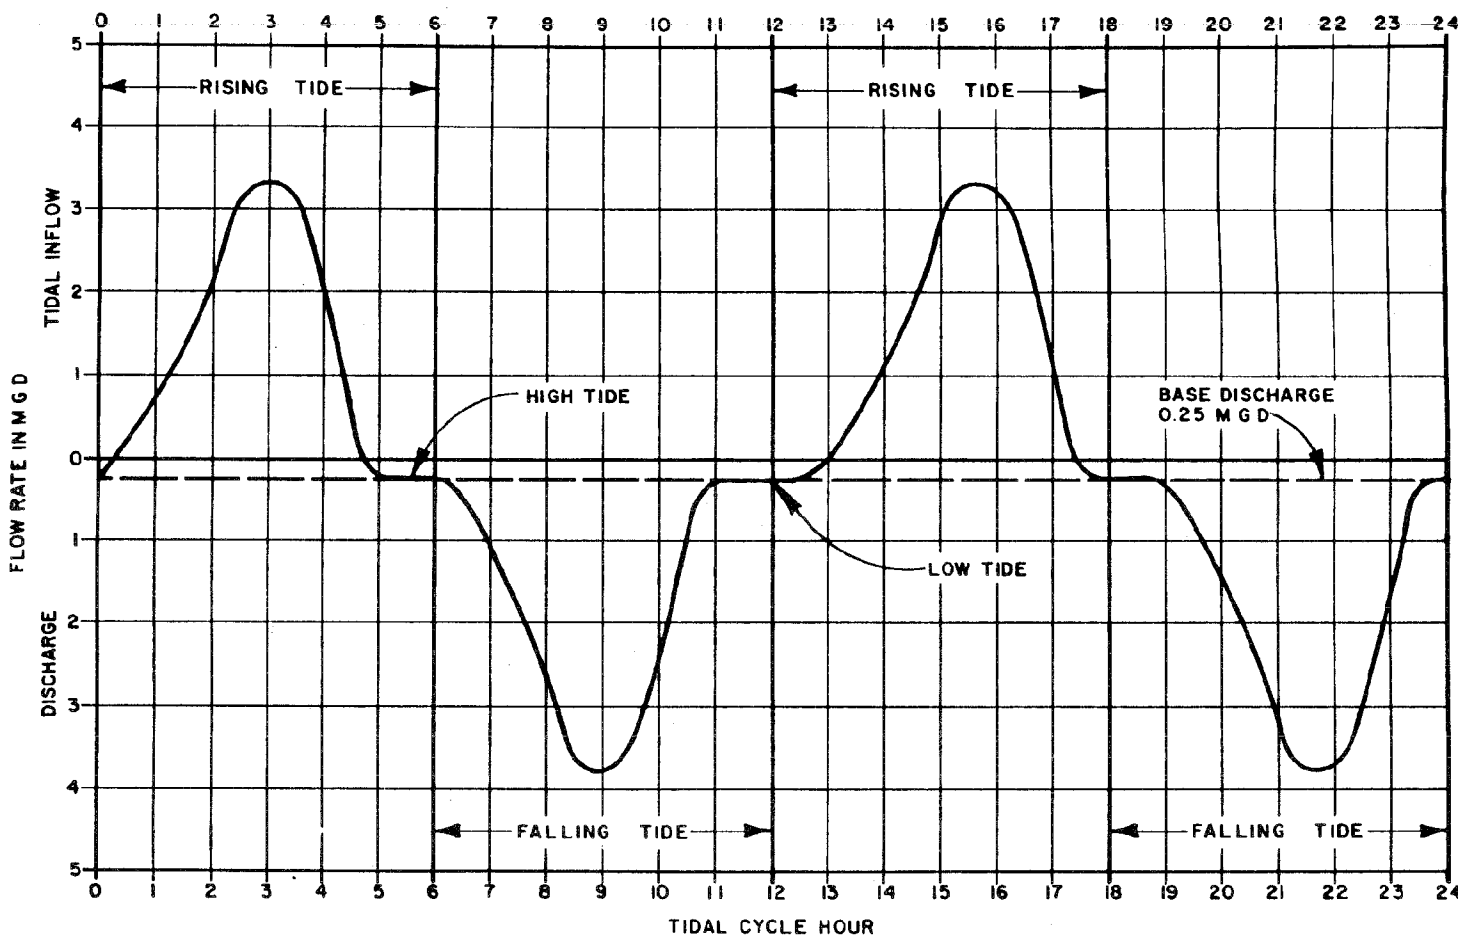
PLATE 9

There was no evidence of chemical attack or deterioration of the concrete chamber. Sediment in the invert of the chamber prevents the Lister Avenue tide gate from closing completely. The gate allows in-flow during the rising tide. Assuming a five foot tidal range and an open tide gate, approximately 270,000 gallons of river water enters with each incoming tide, mixes with pollutants being discharged into the system and flows back into the river as the tide falls. A typical diurnal flow pattern at the tide gate is shown on Plate 9. If
